To: Honorable Mayor and City Council
Through: Charles Dawson, Interim City Manager
From: Tambri Heyden, Acting P&NS Director *T.H.*
By: James Lindsay, Acting Planning Manager *JL*
Subject: O'Toole Elms Arborist Report – Elmwood Development Project
Date: January 11, 2005

ARBORIST REPORT

O'Toole Elms, Milpitas

December 14, 2004

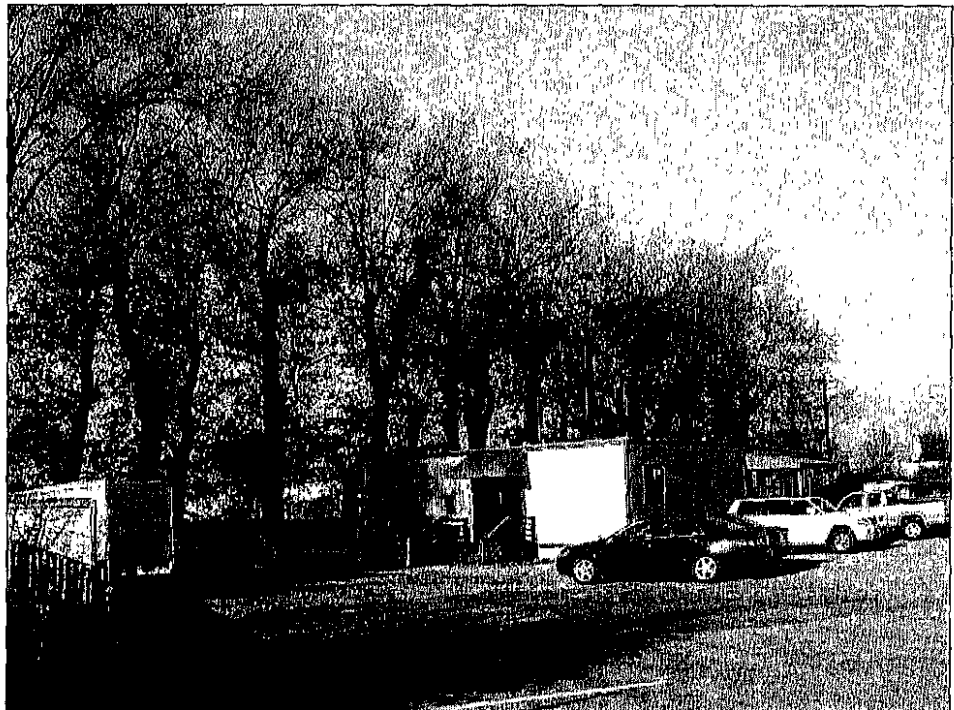
Figure 1. Elm trees #201 through about #217, Northeast to southwest (right to left)

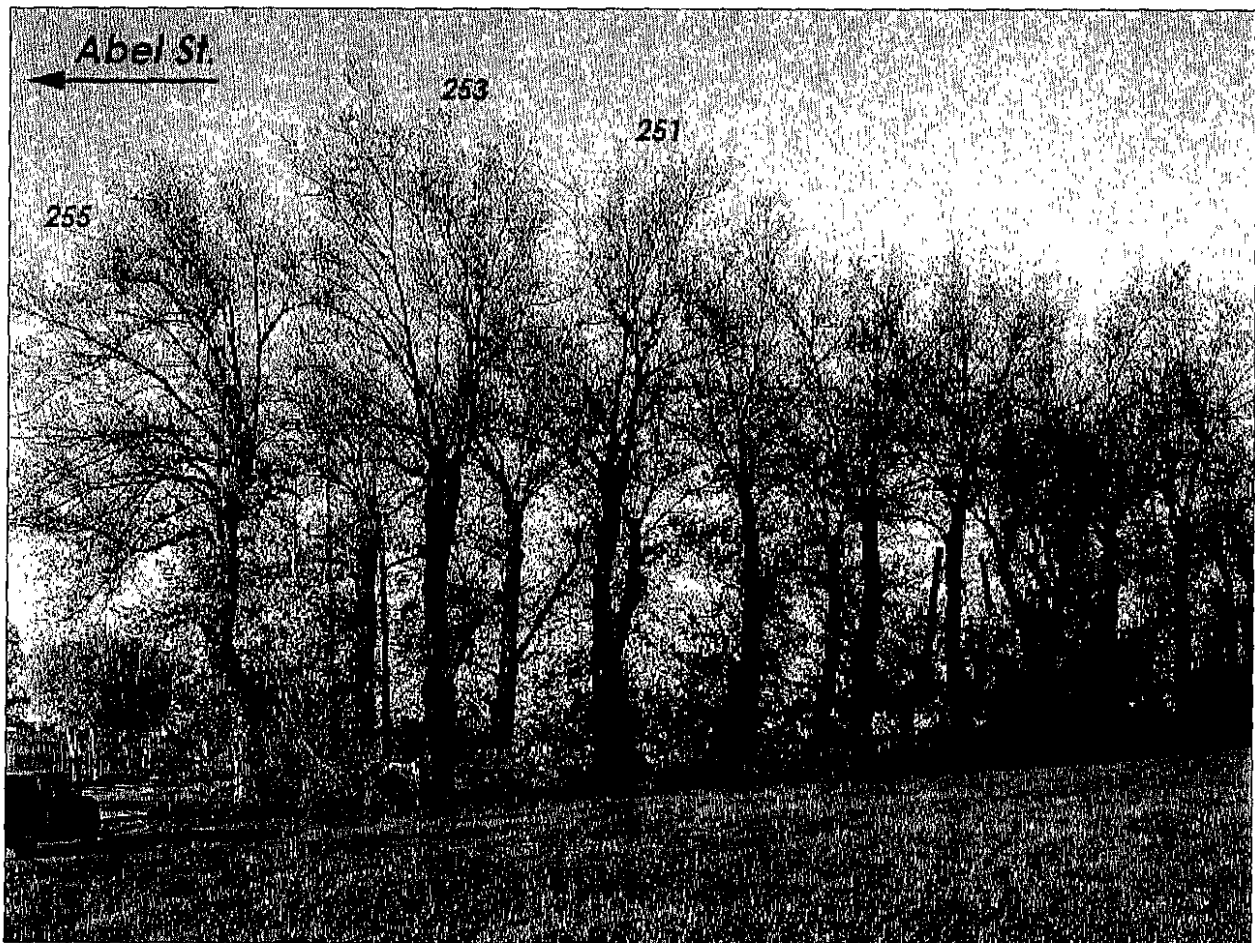
Figure 2. Elm trees #238 to 255, Northeast to southwest (right to left). Elms #251, 252, 253, 254 & 255 (six of the seven elms HortScience listed as tentative to preserve) are numbered.

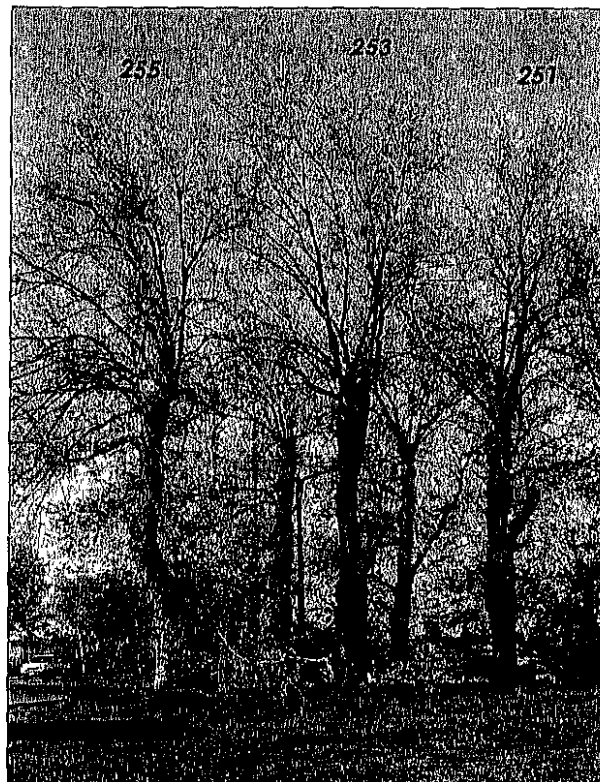
Figure 3. Elms #251 to 255 (Northeast to southwest, right to left).

| Tree # | DBH | Condition (Vigor) | Condition (Structure) | Preservation Suitability | Action | Reason | Notes |
|---|---|---|---|---|---|---|---|
| 251 | 33 | 60 | 40 | Poor | Remove | structure | HS possible save |
| 252 | 34 | 60 | 40 | Poor | Remove | structure | HS possible save |
| 253 | 34 | 60 | 40 | Poor | Remove | structure | HS possible save |
| 254 | 36 | 50 | 20 | Poor | Remove | structure | HS possible save |
| 255 | 36 | 70 | 20 | Poor | Remove | structure | HS possible save |

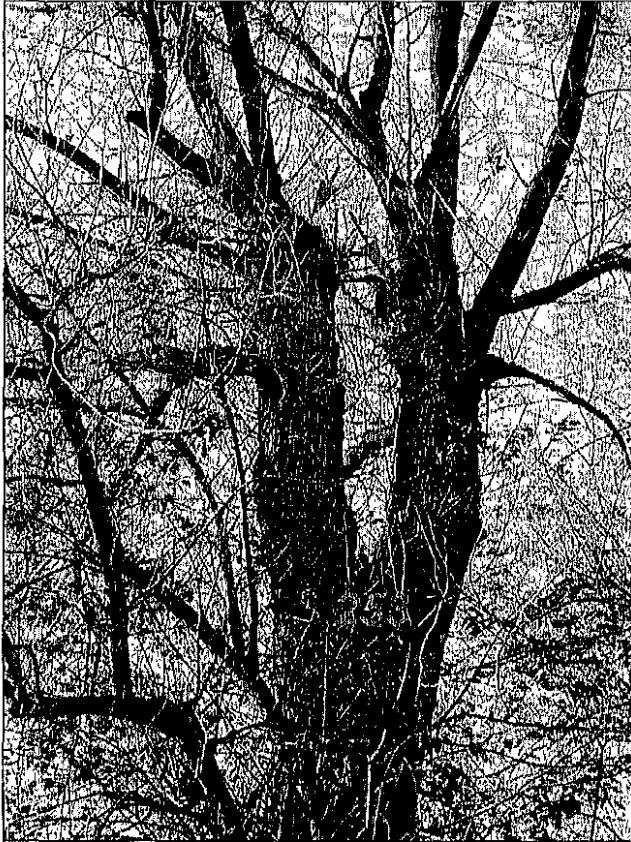
Figure 4. Close-up of upper canopy of elm #253, one of the "seven" elms. The two pink arrows point to large topping cuts that are at least 12 inches in diameter and have decay (probably a significant amount) associated with them. There are several large diameter branches that have grown just below and around these wounds. These branches are very prone to failure, as has been explained in previous reports. In fact, many of these branches (as well as larger portions of the tree including part of the upper trunk) have indeed failed in the past.
